EPiC Series in Built Environment

ASC2022. 58th Annual Associated Schools  
of Construction International Conference

## Assessing the Structural properties of the Sandbag wall for alternative housing construction

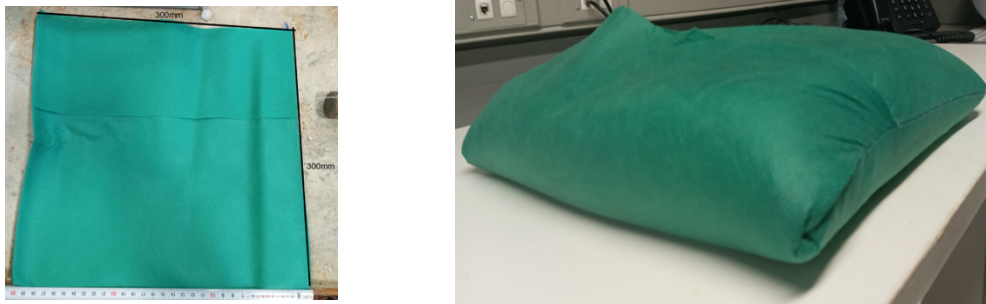
Figure 1. The polypropylene sandbags; empty (left) and filled (right)

The sandbags used measured 300 x 300 mm in size. These bags were made of double-stitched non-woven polypropylene fabric from recycled plastic. When filled, these bags measure approximately 290 x 290 x 60 - 75 mm.

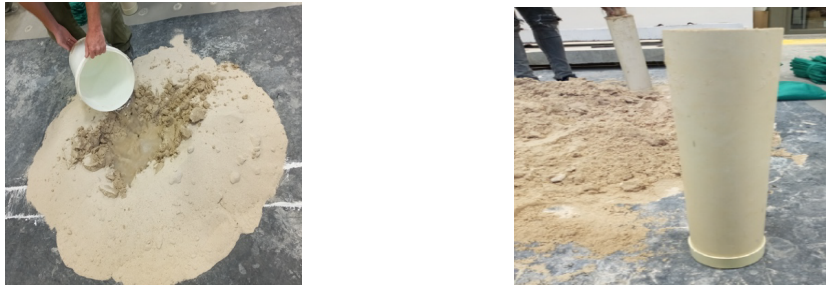
The moisten dune sand was placed in the sandbags using a cylindrical PVC container for the wall construction, as illustrated in Figure 2. Before filling, the fill materials were brought to their optimum moisture content to aid in compaction. This moisture content was determined for each material during testing. Dune sand and crusher dust had a water content of  $\pm 10\%$  and  $\pm 3\%$ , respectively. The bags were filled to mass between 7 and 8 kg for both materials. Once filled, the bags were closed by flipping the foldable collar on the bag over the opposite side and flattened using a wooden paddle.

Figure 2. Bag filling preparation; moisten the sand; fill the PVC cylindrical container, and fill the bag
